Expert Mission to the Philippines

Damages caused by Tropical Storm Washi

Assessment Report of the damages caused by Tropical Storm Washi

TYPHOON COMMITTEE EXPERT MISSION
23-27 April 2012

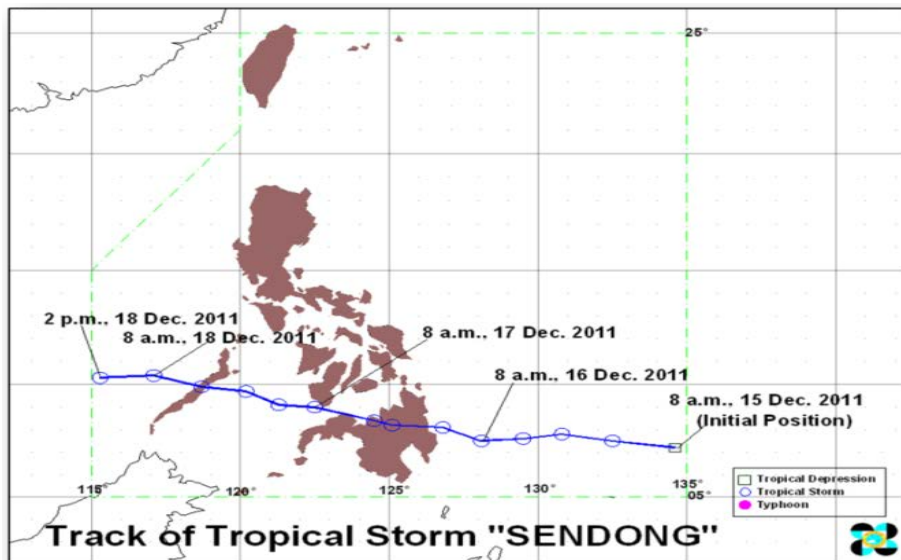
Fig. 1- Track of Tropical Storm Washi(Sendong) – Philippines local time

The severe tropical storm Washi was the twenty-first tropical cyclone formed in the area covered by the Typhoon Committee, in 2011. It was initially classified by the Regional Specialized Meteorological Center (RSMC) Tokyo as a Tropical Depression on 13 December 2011, at 06 UTC, and was originated over the sea southeast of Yap Islands. Moving westward, it reached the classification of Tropical Storm west of the Palau Islands at 06 UTC of 15 December. The

maximum sustained winds reached 50 kt, which permitted to be classified as severe tropical storm, and a minimum central pressure of 992 hPa was detected east of Mindanao Island at 06 UTC on 16 December. Keeping its westward track, Washi crossed Mindanao Island that day and the Sulu Sea on 17 December, traversing the provinces of Agusan del Sur, Bukidnon and Misamis Oriental. Keeping its westward track, it was downgraded to tropical depression intensity in the South China Sea at 00 UTC on 19 December and dissipated approximately six hours later.

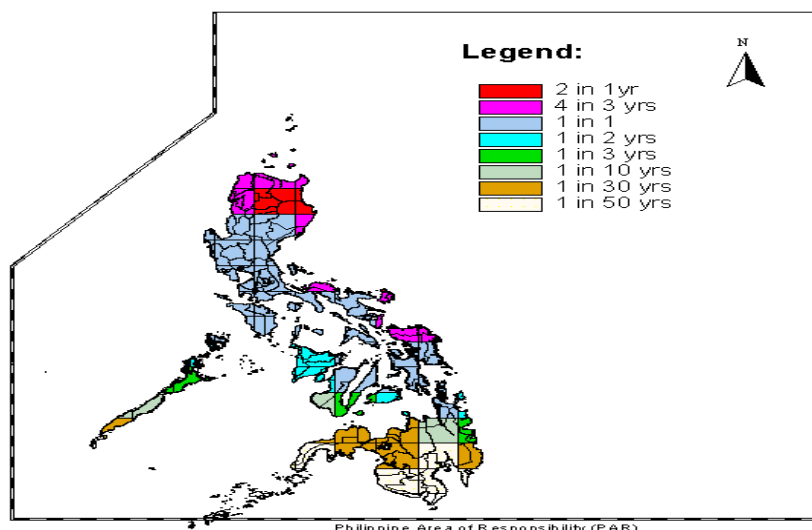
Fig. 2- Frequency of tropical cyclones occurrence in the Philippines

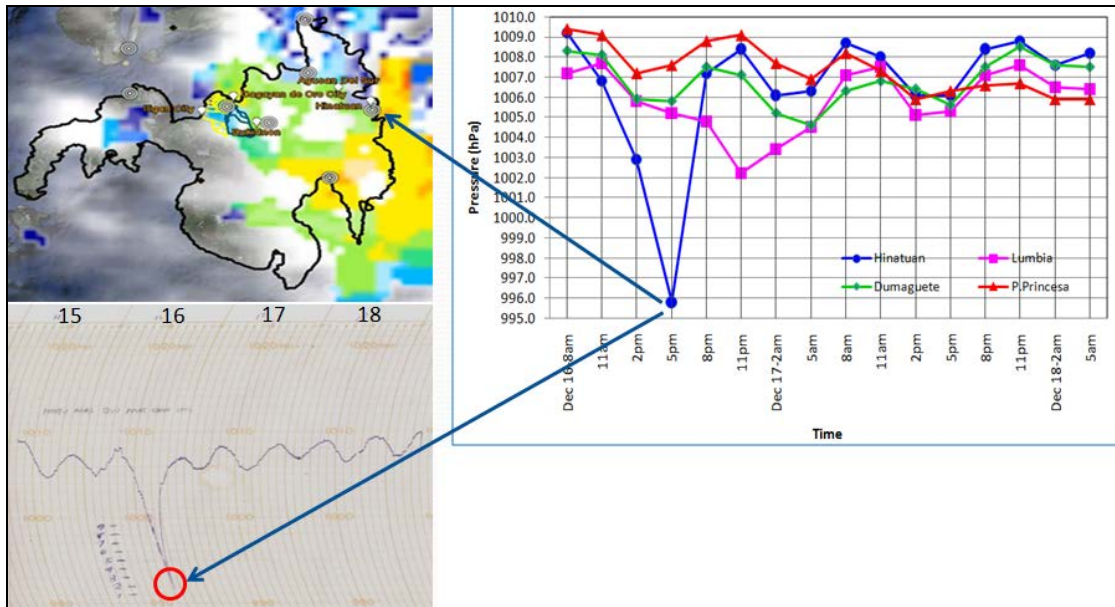
Fig.3- Observed 3-hourly mean sea level pressure (right) at PAGASA synoptic stations and barograph measurements at Hinatuan station (lower left) during the passage of TS Washi (Philippines local time)From: A retrospective on the devastating impacts of Tropical Storm Washi -Susan R. Espinueva, Esperanza O. Cayanan and Nivagine C. Nievares – PAGASA)

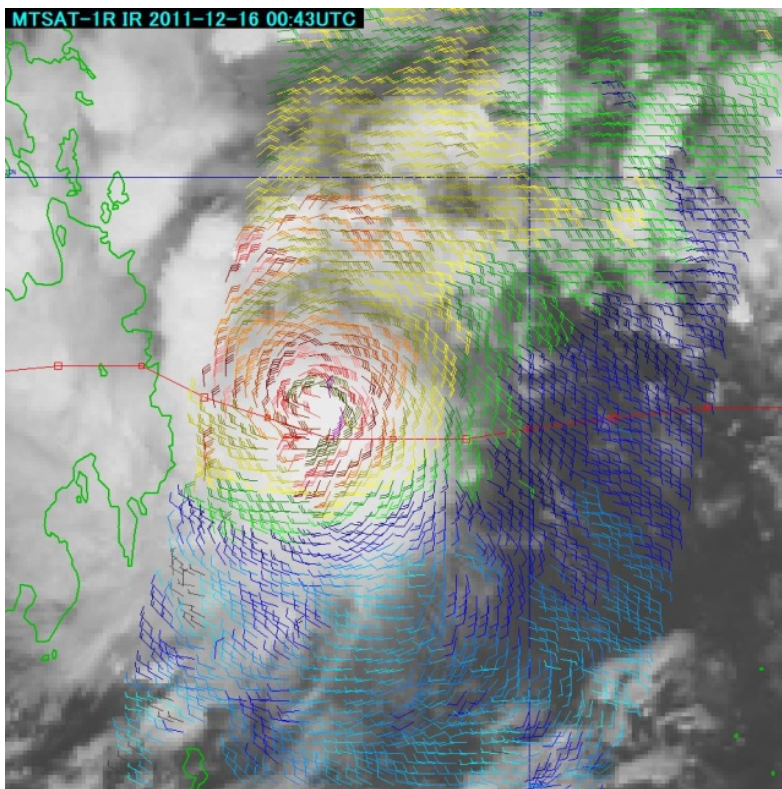
Fig. 4 - IR image and ASCAT

This image shows the cyclonic circulation of winds associated with Washi.

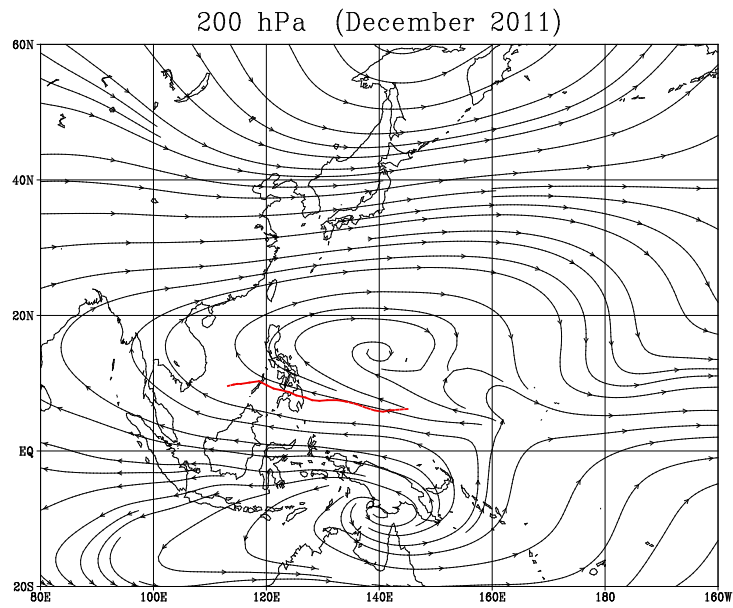
Fig. 5 - Monthly mean of stream lines at 200 hPa - December 2011
Track of Washi is superimposed. (Provided by the RSMC Tokyo)

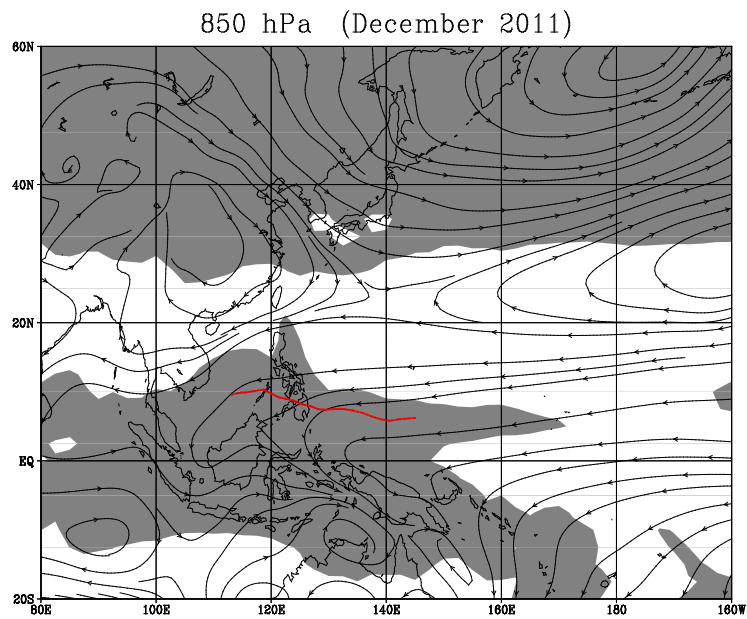
Fig. 6 - Monthly mean of stream lines at 850 hPa- December 2011
Track of Washi is superimposed. (Areas of outgoing longwave radiation - OLR) lower than 230W/m^2 are shaded in this chart.
(Provided by the RSMC Tokyo)

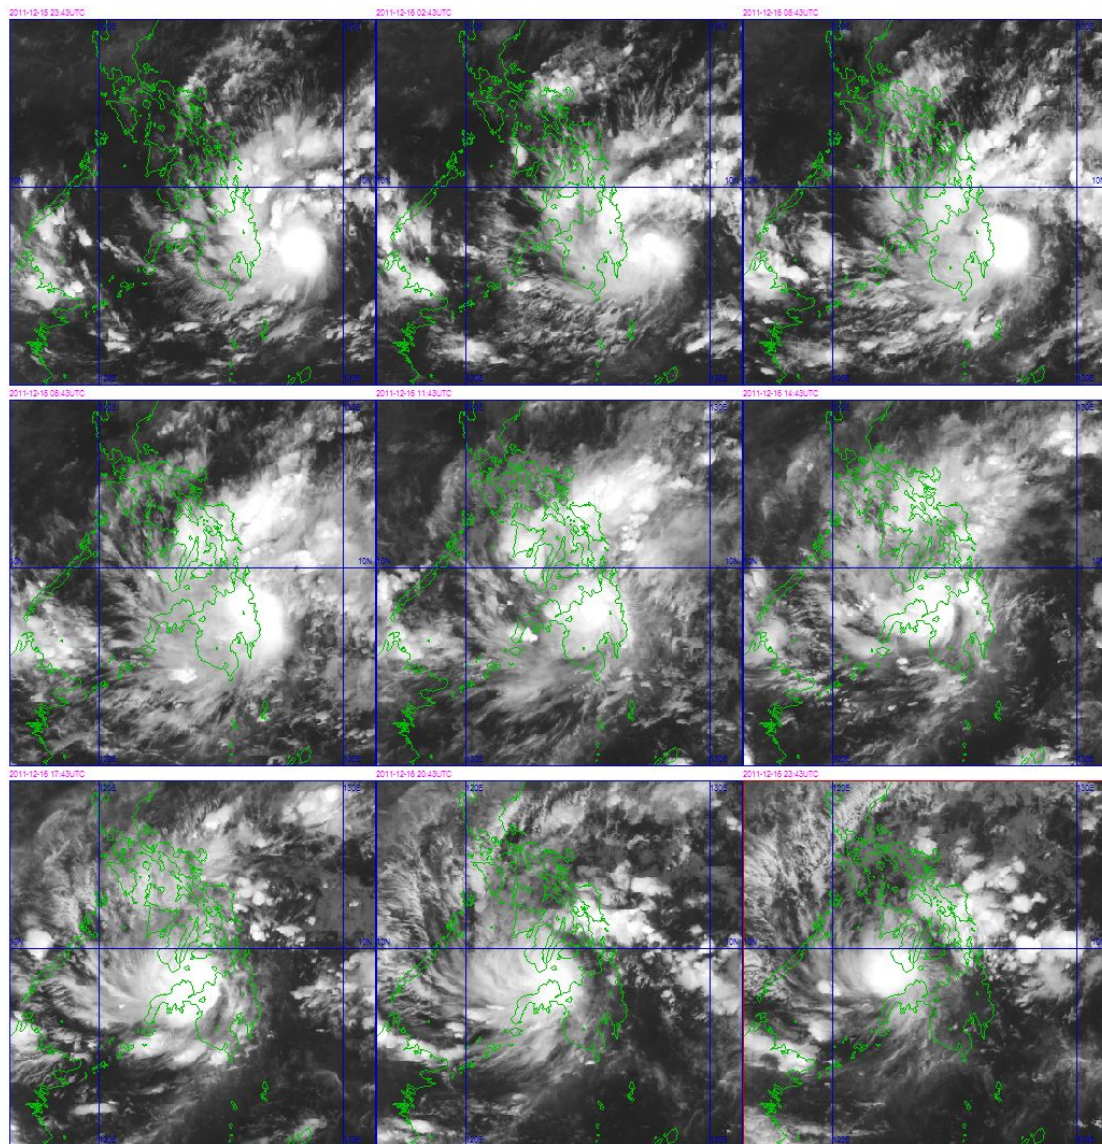
Fig. 7 - IR images from 16 Dec 00UTC to 17 Dec 00UTC(Provided by the RSMC Tokyo)

This succession of infrared images illustrate Washi approaching and passing over Mindanao (provided by the RSMC Tokyo)

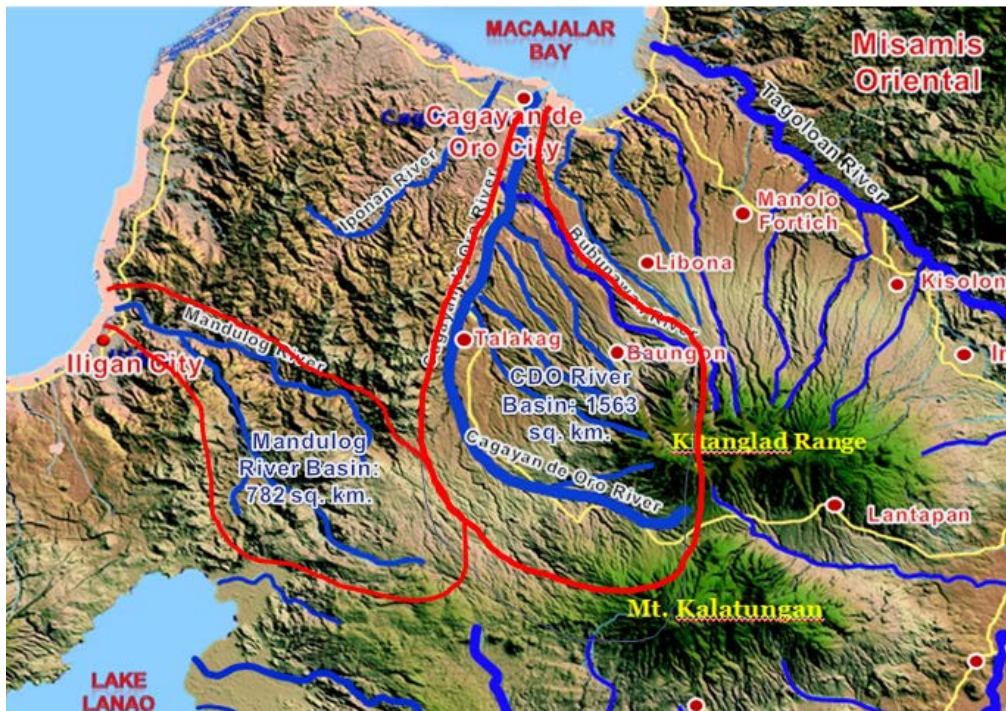
Fig. 8 - Part of the map of Mindanao, showing the basins of the Cagayan de Oro and Mandulog rivers.

The Cagayan de Oro River and Mandulog rivers

The Cagayan de Oro River drains at the Macajalar Bay, close to the city with the same name. It has as main tributaries the rivers Tagiti, Mamala, Samalauan and Bubunawan, and the drainage area of the basin is 1563 sq. km. One of the most devastated zones of the downstream area of the basin was Isla de Oro, in CDO City, where homes and people were swept out to sea.

The Iligan City is located in the downstream area of the Mandulog river, which drains at Iligan Bay and whose basin has a drainage area of 782 sq. km.

Both the rivers have their course through a mountainous region, which facilitated the inflow of water during the huge rainfall associated to the Washi.

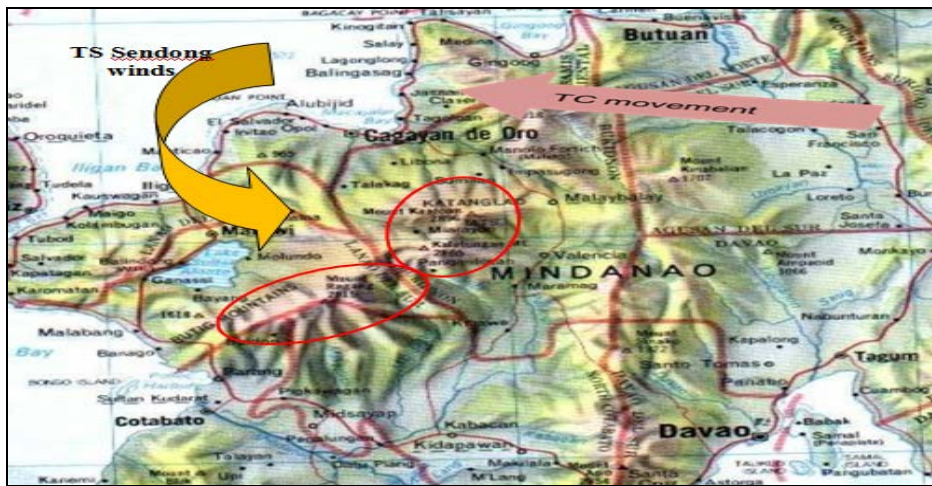
Fig. 9 - Topographic map of northwestern part of Mindanao

One of the reasons of the huge quantity of precipitation that felt on the basin of the CDO and Mandulog rivers is likely due to the orographic effect caused by the mountains surrounding the two rivers. Fig. 9 shows the track of Washi and the predominant direction of the winds when the tropical storm passed through the region most affected by the rainfall.

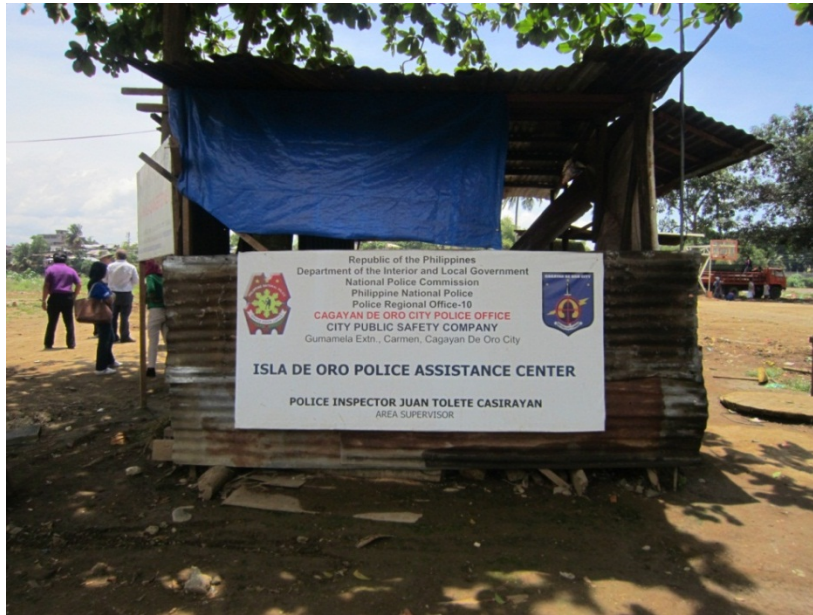
Fig. 10 - In Isla de Oro, the police take measures to prevent the Reconstruction of houses in unsafe sites

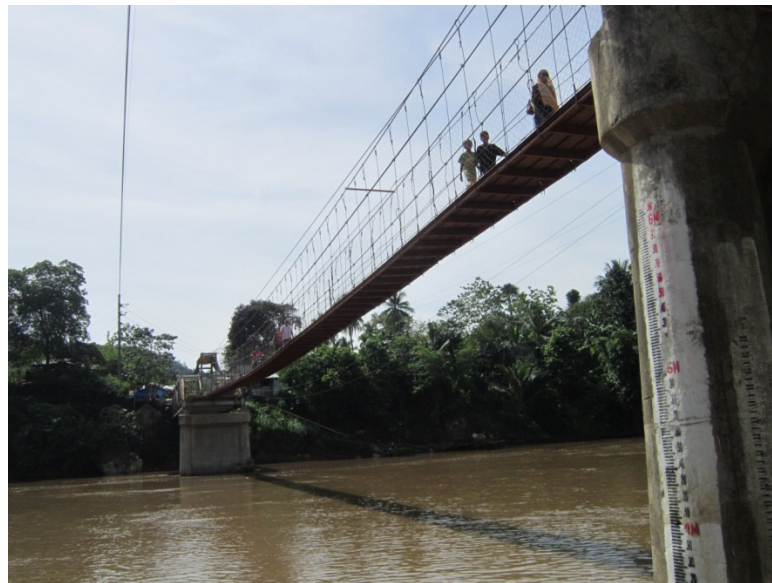
Fig. 11 - Hanging footbridge constructed after the destruction of the Bridge (Cabula-Maasin, Bukidnon province)

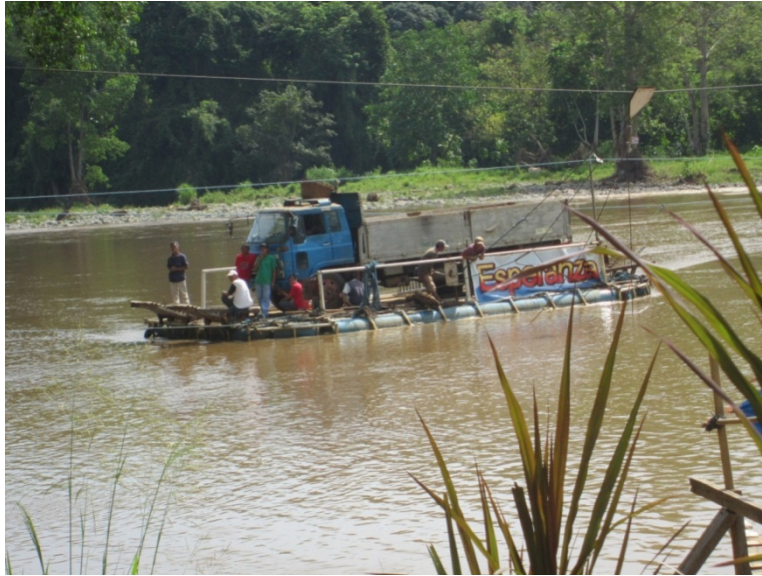
Fig. 12 - The bridge was destroyed, but the human skills try overcome difficulties (Cabula-Maasin, Bukidnon province)

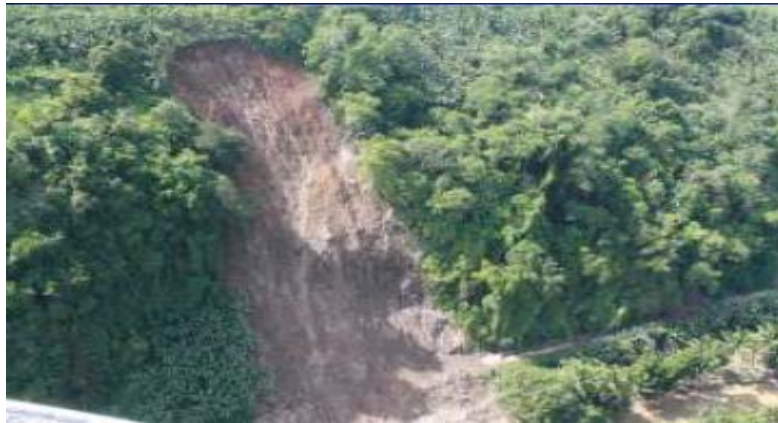
Fig 13 - Landslide in the upstream of the Cagayan de Oro River
(Source : PAF – OCD aerial survey 21December 2011)

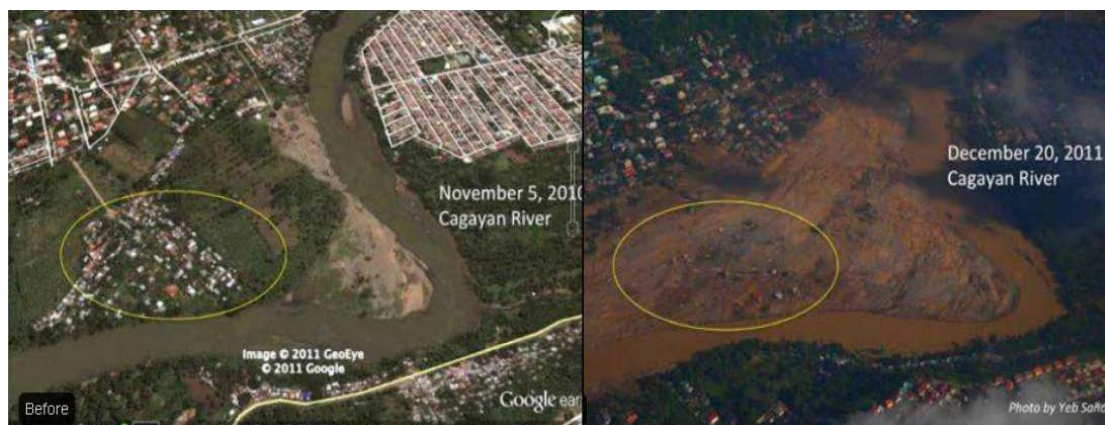
Fig. 14- Photo of Barangay Macasandig, CDO City, before and after the floods.
