# **Cause, Assessment & Management of Flood Hazards associated with Landfalling Tropical Cyclones & Heavy Rain**

**Chen Charng Ning, Professor Emeritus  
Nanyang Technological University (NTU), Singapore  
Consultant, Water Resources Engineering**

***WMO Typhoon Committee Roving Seminar  
Kuala Lumpur, Malaysia; 20-23 September, 2011***

# **Case Assessment of the Failure of 'New Orleans Flood Protection System' from Hurricane Katrina -**

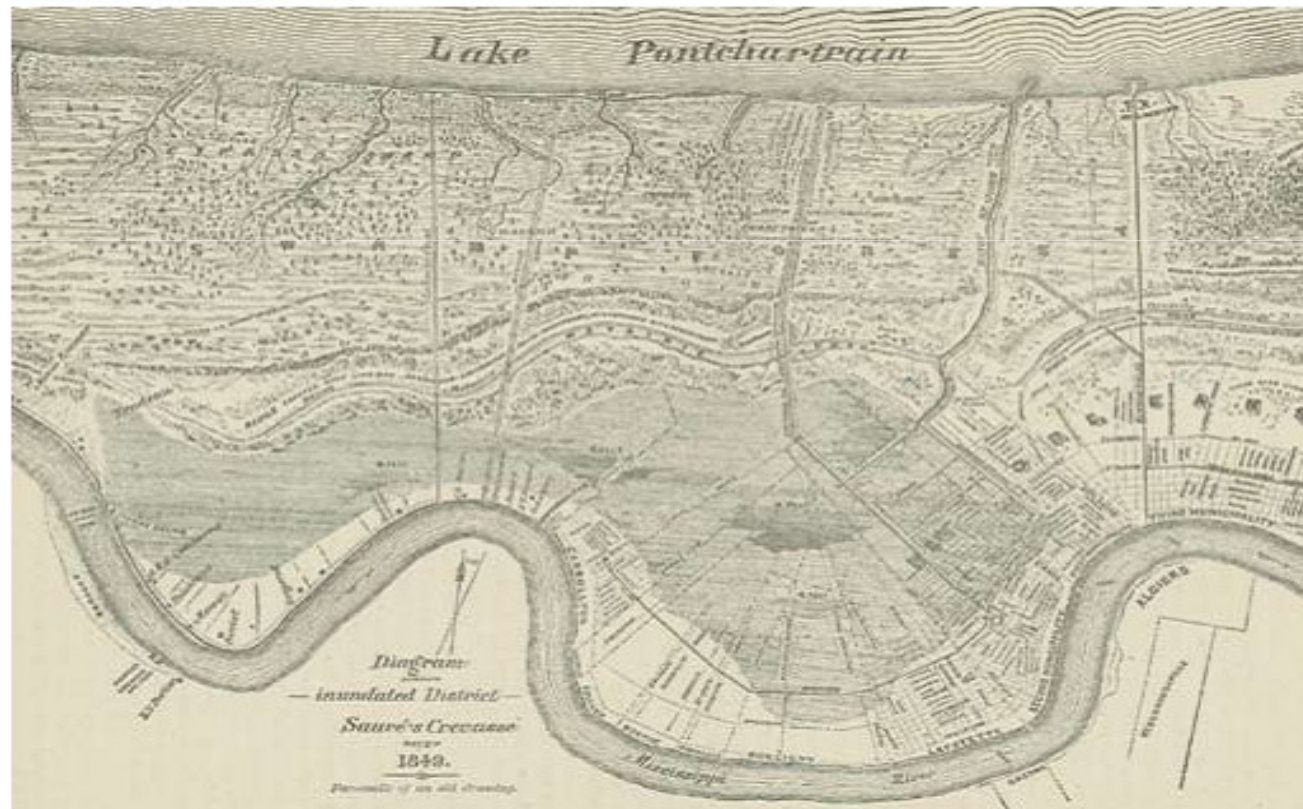
*New Orleans in 1849*

*An 1849 map shows New Orleans built adjacent to the Mississippi River, with marshlands and bayous to the north.*

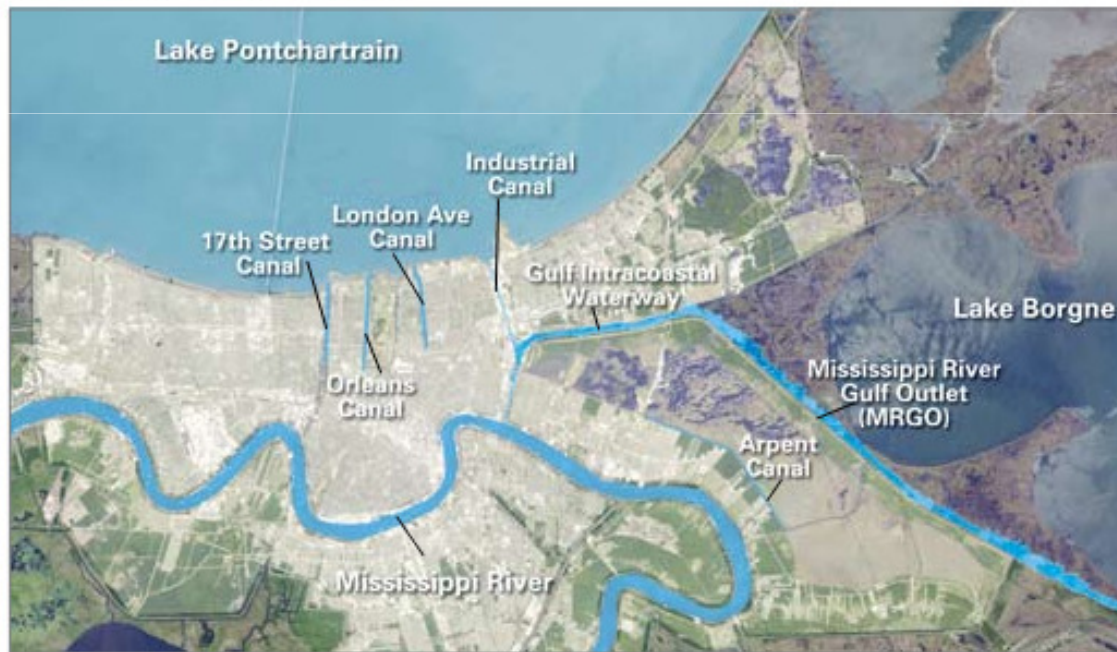
*The New Orleans Waterways*

*New Orleans is surrounded by – and inter-fingered with – water: lakes, rivers, bayous, and canals.*

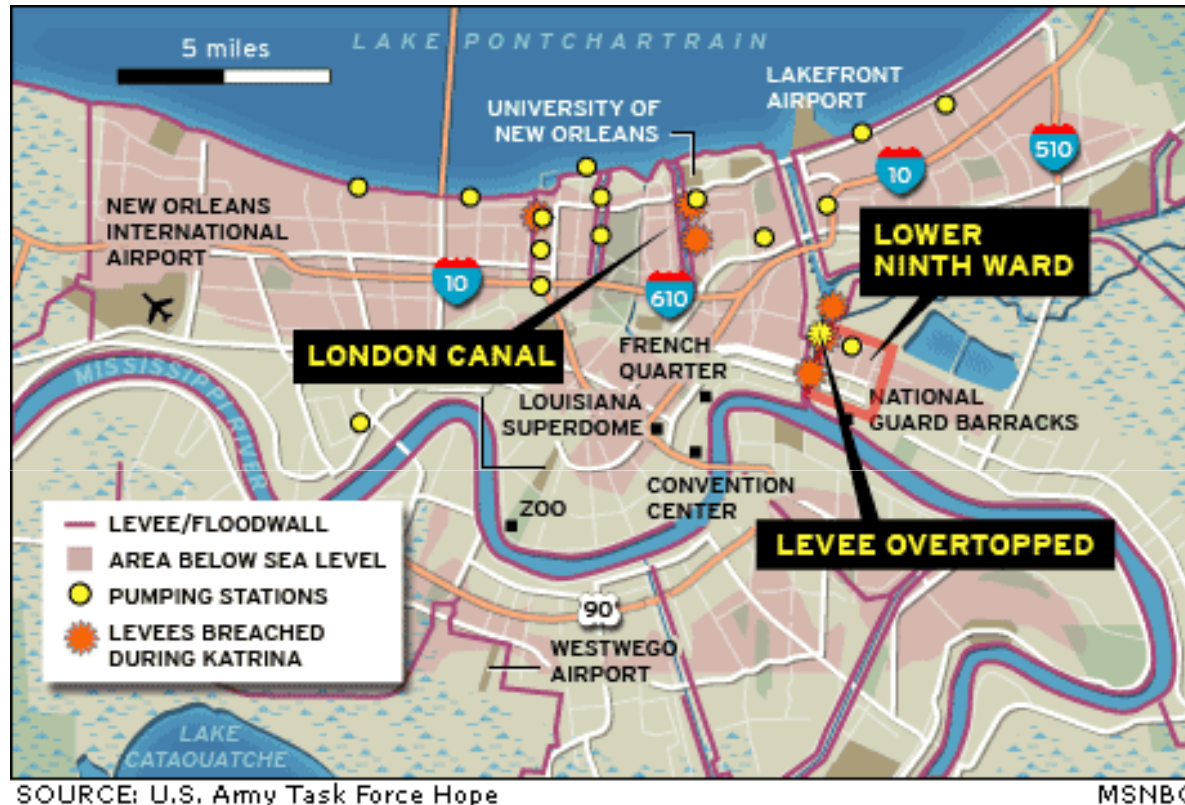
- Levees & flood walls were built by USACE and others
- Interior drainage & pumping stations are by others
- All O&M are by local agencies & levee boards

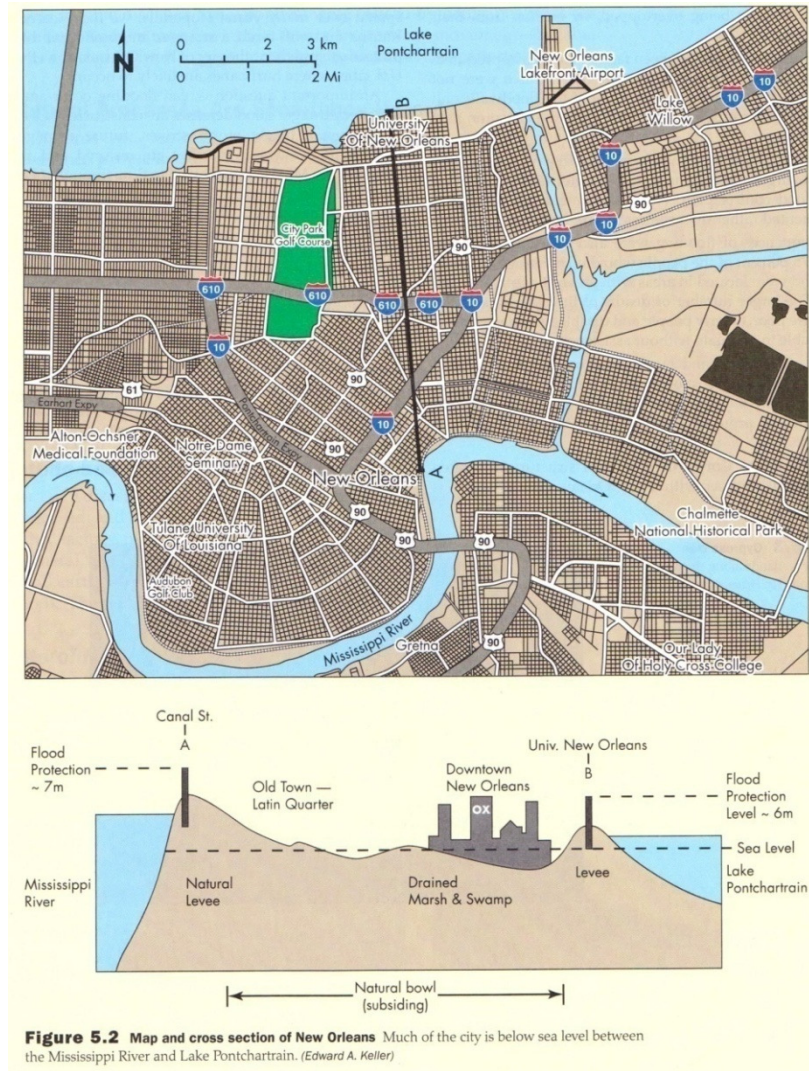
- Much of New Orleans is below sea level—a series of large ‘bowls’ surrounded by levees.
- Interior drainage system, including pump (lift) stations, outfall pump stations, and outfall canals, are designed to dispose of rain water, but not to remove water from overtopping or breaches
- Most pump stations are designed for 10-yr, 24-hr storm, or 9 inches of rainfall
- Mixture of new and old (100-yr age) pumps. Some are diesel driven, and others are provided by electric grid with back-up diesel generators.

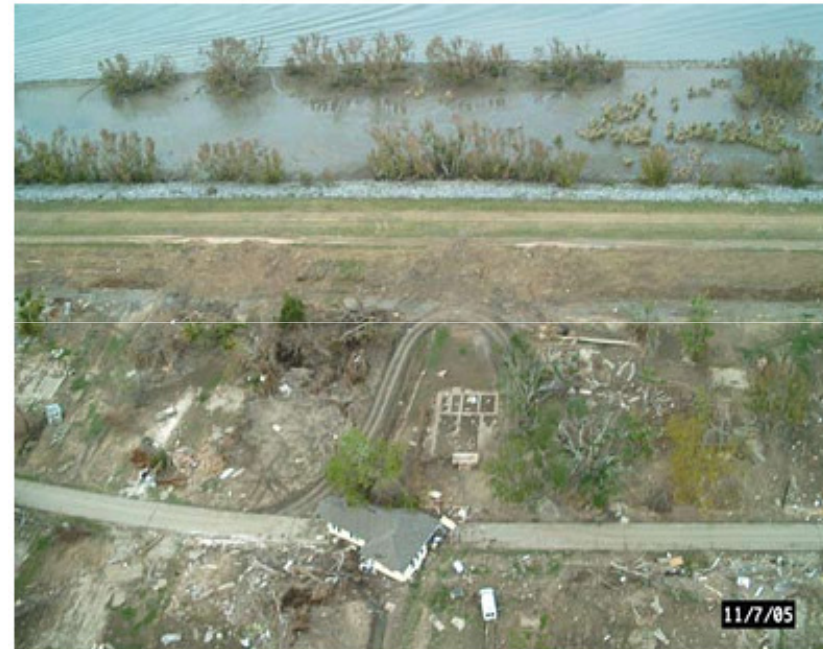
*Hurricane Damage in Plaquemines Parish*

*The storm surge from Hurricane Katrina overtopped levees (seen in this photo adjacent to the water) in Plaquemines Parish and knocked hundreds of homes off their foundations. (This photo was taken after flood waters had receded.)*

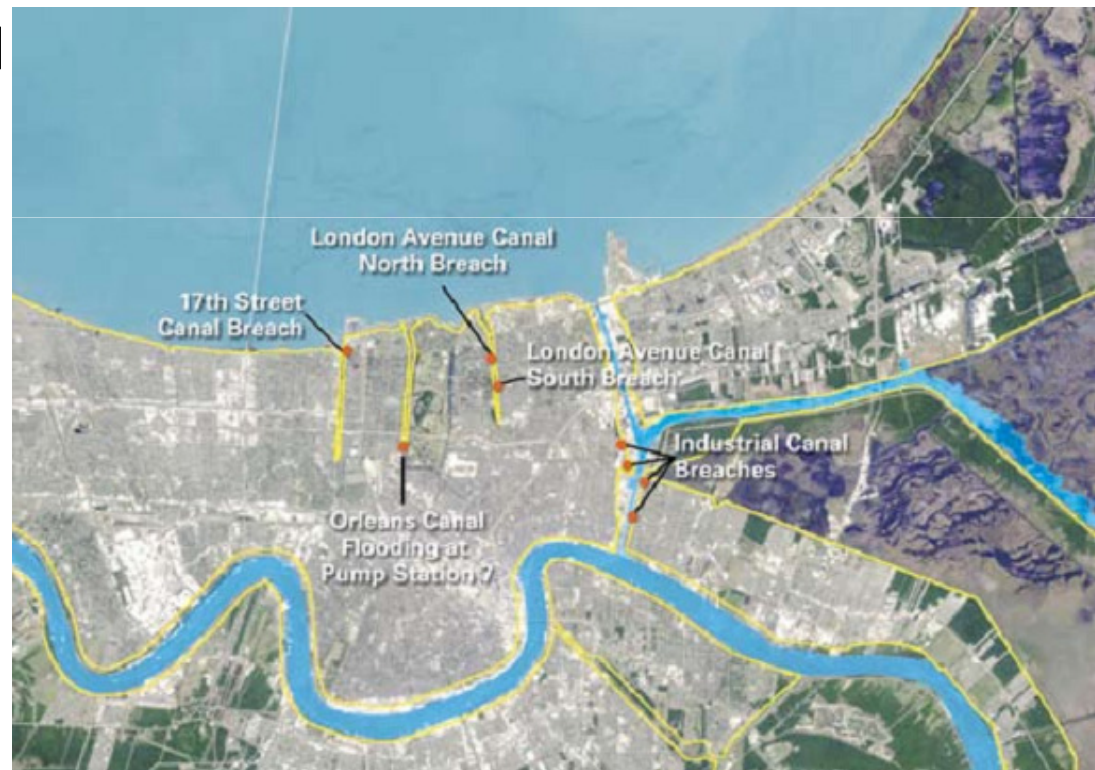
Ruptures (or breaches) in four I-walls developed, all before water levels in the adjacent canals overtopped them.

- East bank of Industrial Canal I-wall
- I-wall at 17<sup>th</sup> St Canal
- London Ave Canal I-wall (south breach)
- London Ave Canal (north breach)

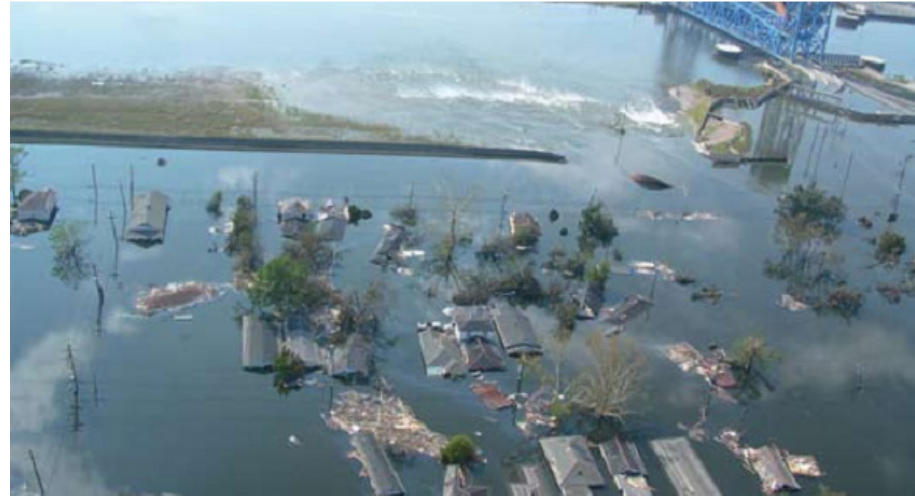
North Breach >

5:00 am: breach in east  
bank of I-wall of  
**Industrial Canal**

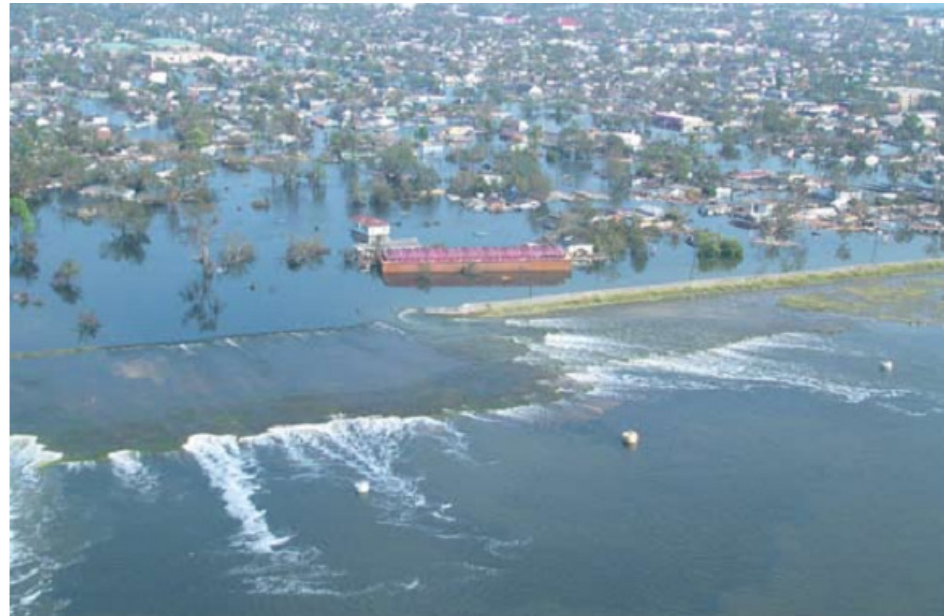
South Breach >

\* Photos were taken after  
flood water began to  
recede

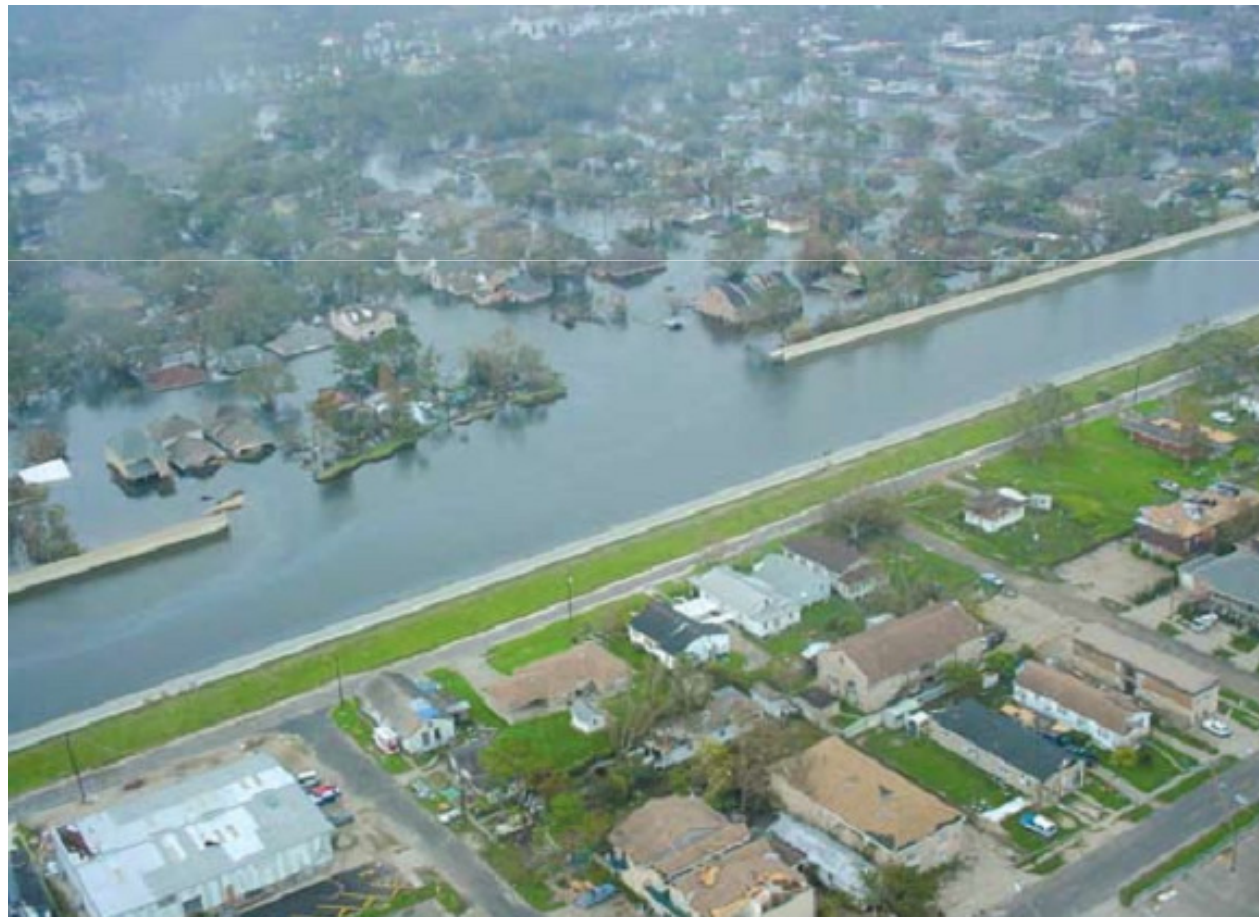
6:30 am: breach of I-wall at **17<sup>th</sup> St Canal** began

9:00 am : torrents of water from Lake Ponchartrain rushing in thru 450-ft long breach segment

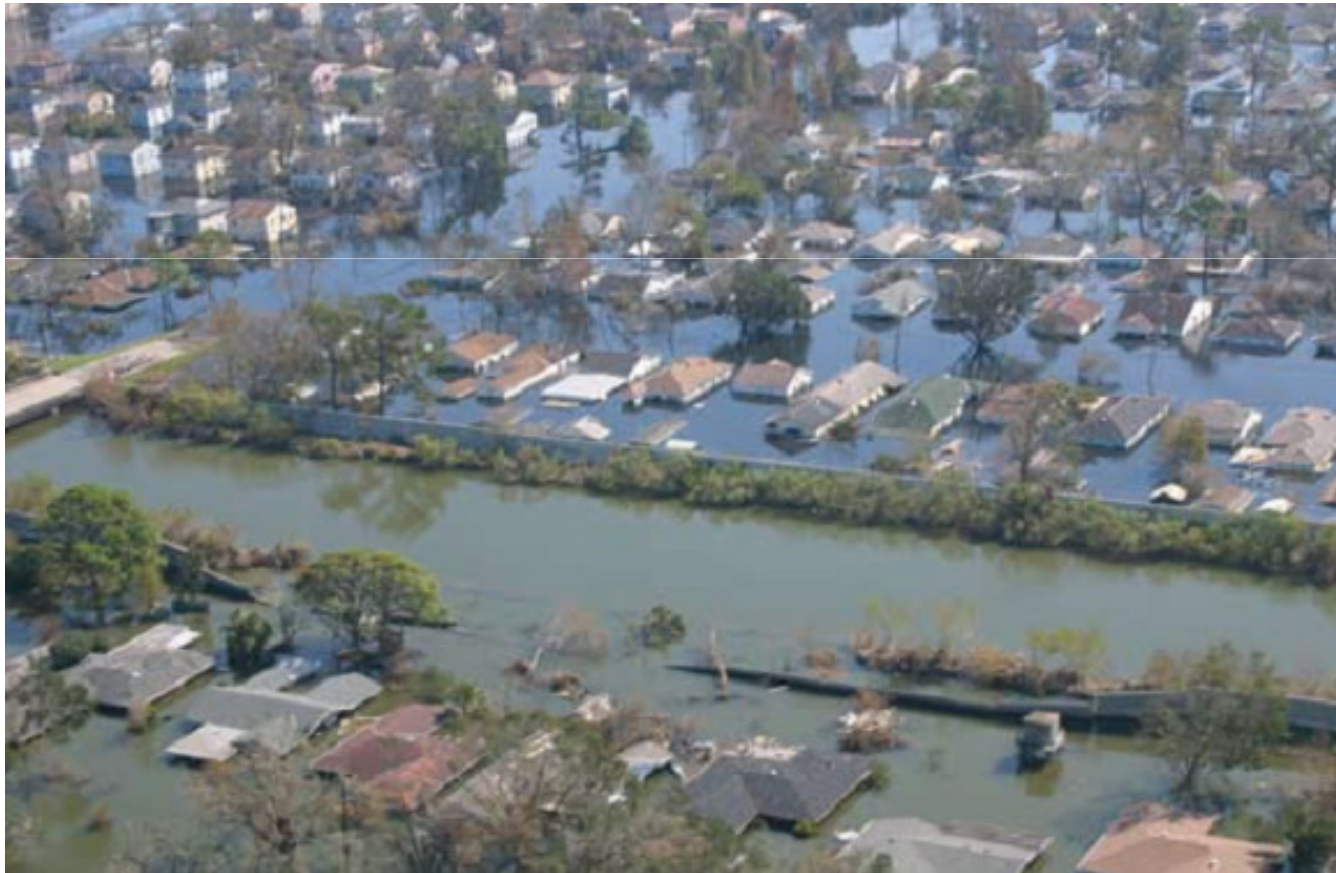
7:00 am: breach in a London Ave Canal I-wall (south breach)

8:00 am: 2<sup>nd</sup> breach at London Ave Canal north breach) **V**

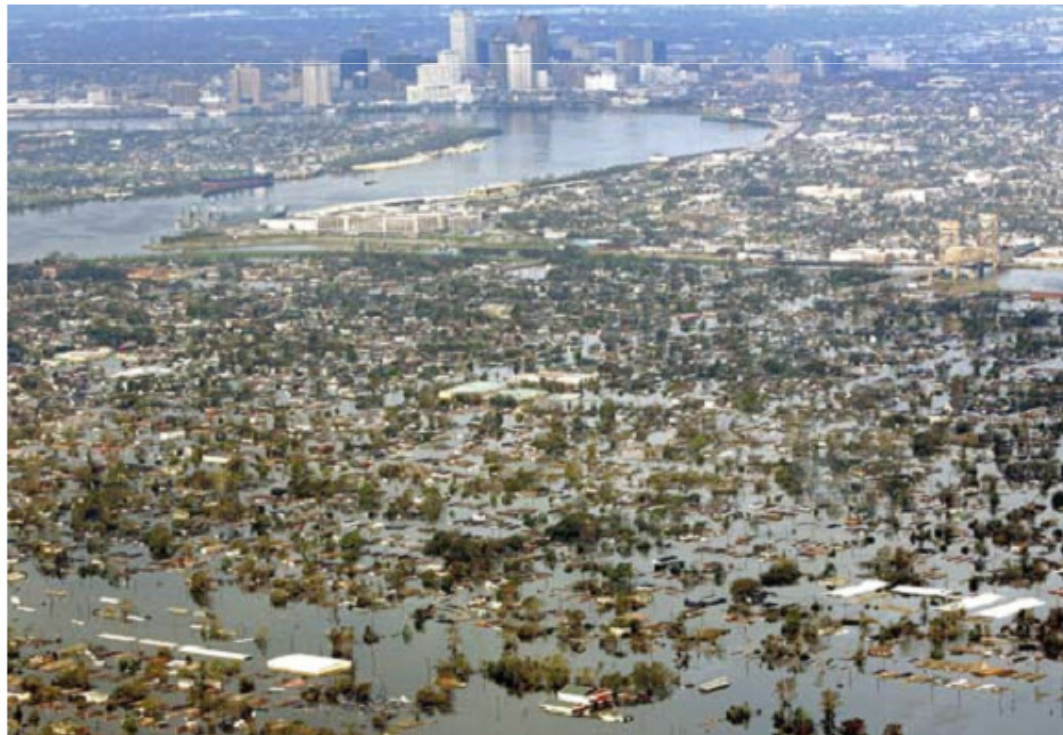
*New Orleans Flooded*

- Peak surge levels were over when most of the major I-wall failures occurred.
- Flooding continued until water level in the bowl-shaped landscape equalized with that in Lake Pontchartrain.

By Sept. 1<sup>st</sup>, over 80% of metropolitan New Orleans was flooded (2/3 from breaches and 1/3 thru overtopping & rain)

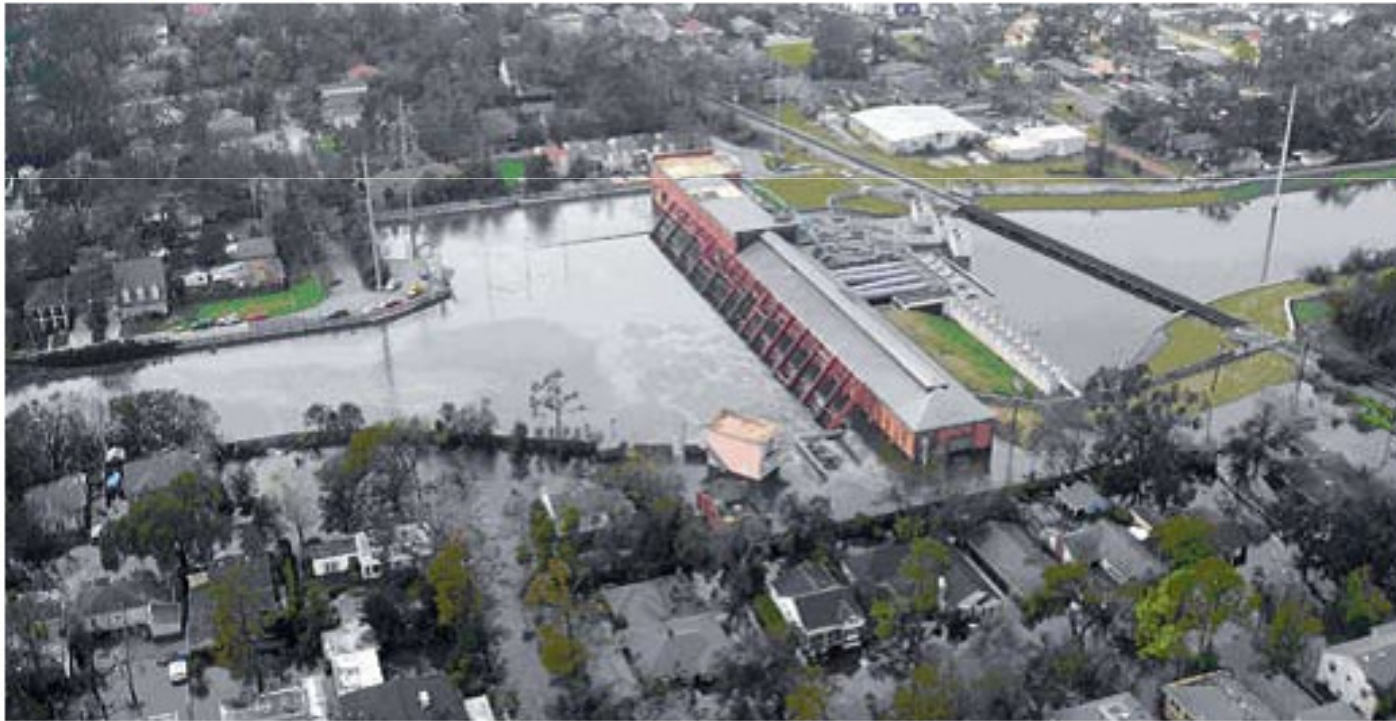
*Submerged Pump Station No. 6*

*Rapid and far-reaching flooding caused by the hurricane protection system failure left most pump stations, such as Station No. 6 (on the 17th Street Canal), inoperable.*

Pump stations could offer no relief to flooding as they were mostly left inaccessible and inoperable by the failure of the hurricane protection system

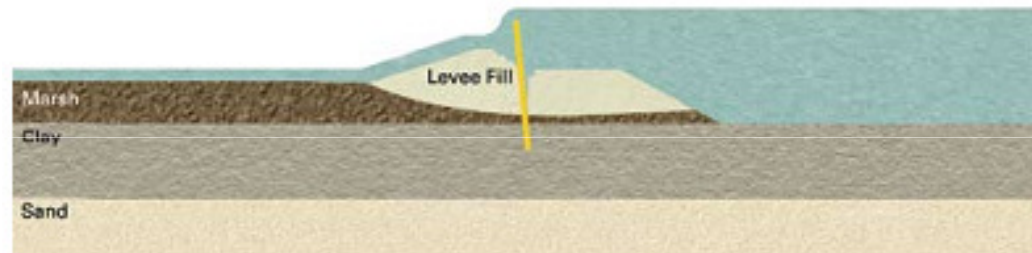
*2: The water scours soil from the land-side of the I-wall and washes it away.*

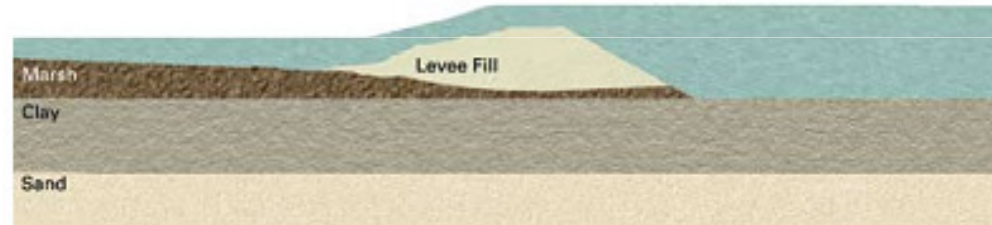
*2: The water scours soil from the crest and land-side of the levee and washes it away.*

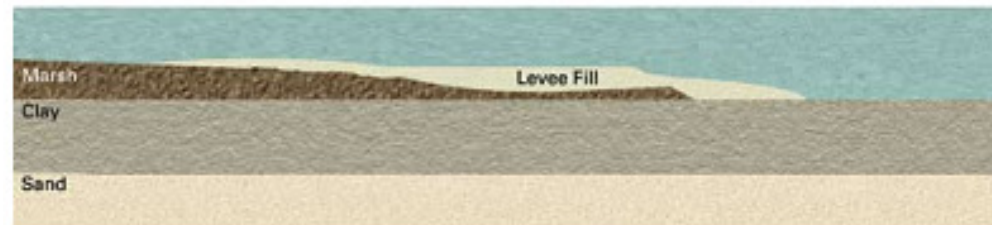
*3: Some levees constructed of sand and silt washed away completely.*

- Levees with properly compacted clay & good grass cover withstood the storm the best.
- Levees with higher silt & sand content, or built with hydraulic fill sustained the worst erosion damage, and in some cases were completely washed away.

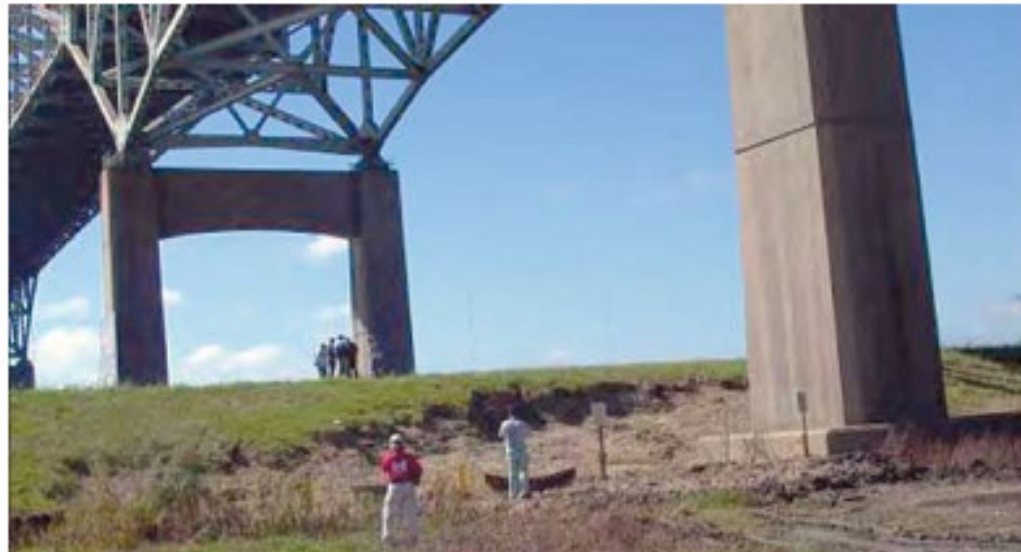
*Levee Under the Paris Road Bridge in New Orleans East*

*Even though this earthen levee was overtopped (as was shown in Figure 5.1), it sustained relatively minor damage. (This photo was taken after floodwaters had receded.)*

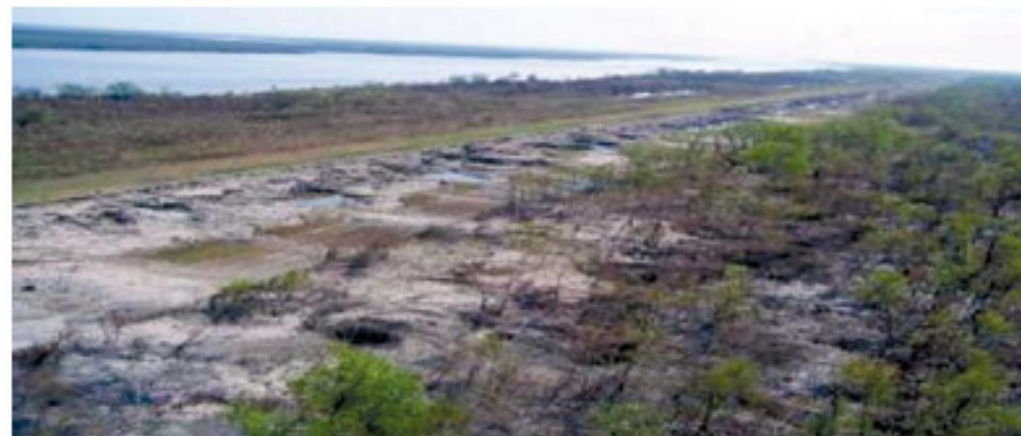
*Obliterated Levee along the Mississippi River-Gulf Outlet*

*Many levees that were constructed with hydraulic fill severely eroded or washed away entirely. (This photo was taken after floodwaters had receded.)*

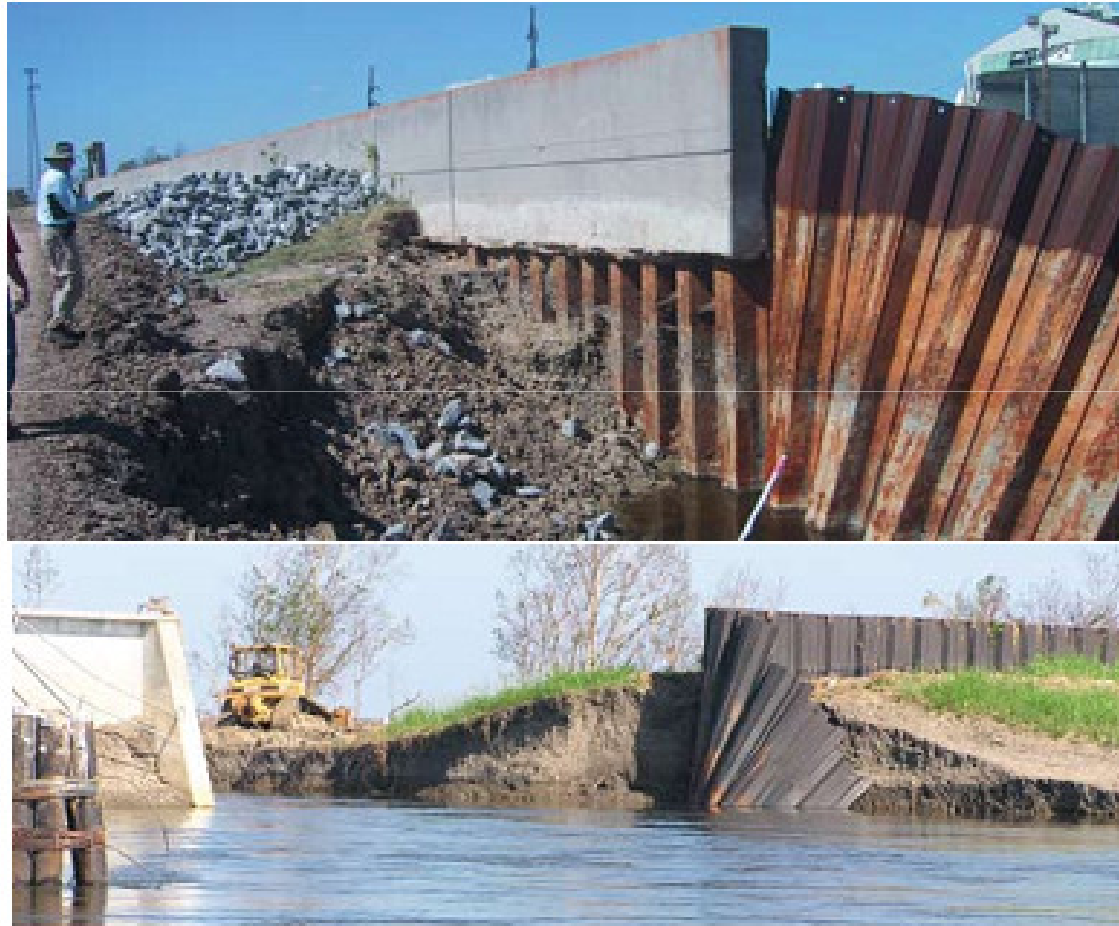
*Failed I-Wall and Levee Sections*

*The levees and I-walls were constructed piecemeal with different top elevations and of different materials: earth, steel, and concrete. The floodwaters preferentially attacked the lower-elevation erodible earth first, causing major breaches.*
